# NOV TDX-1250 Traveling Block Dolly

## CAT IV Inspection, Structural Overhaul & Repair

Performed by: Loadmaster Industries, LLC | Broussard, Louisiana

Reference: FDR# 22165-001 through 22165-006

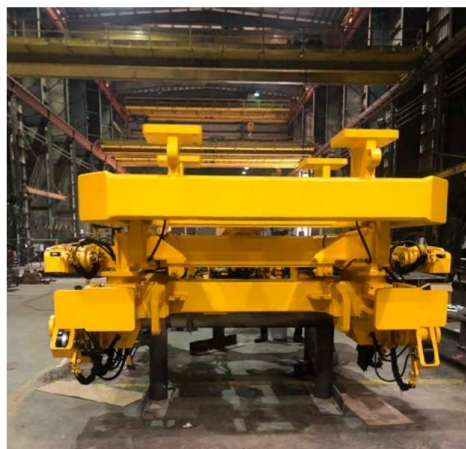
*Figure 1 — Front view of the TDY-1250 Block Dolly following disassembly, inspection, structural repairs, and 3-coat marine paint application*

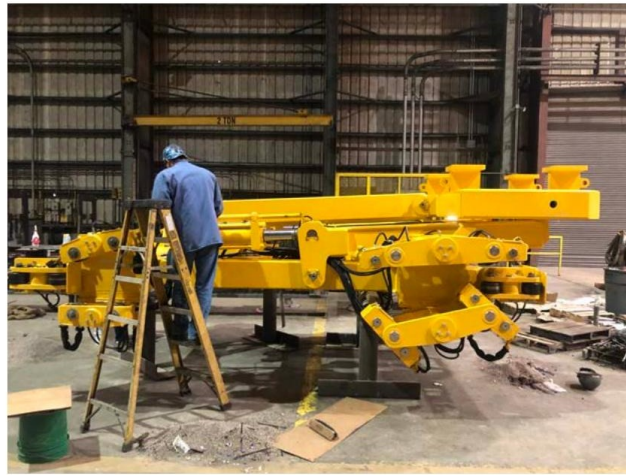
Figure 2 — Side elevation view showing hydraulic cylinder, arm linkage assembly, and lower arm connection points during final assembly verification

| FDR # | Component | Finding / Deficiency | LMI Corrective Action |
|---|---|---|---|
| 22165-002 | Lower Arm Connection Padeyes | Padeyes bent; cracked welds identified. Internal damage found upon opening frame (gussets, 3" padeye connections) | Removed (4) damaged padeye plates; replaced with new. Repaired internal gussets & connections. Engineering/Drafting, Line Boring included |
